NAVAL POSTGRADUATE SCHOOL

THESIS

**A FIRST REPORT ON ELECTROMIGRATION STUDIES AT A
MODEL COPPER-ALUMINUM RAILGUN CONTACT**

December 2006

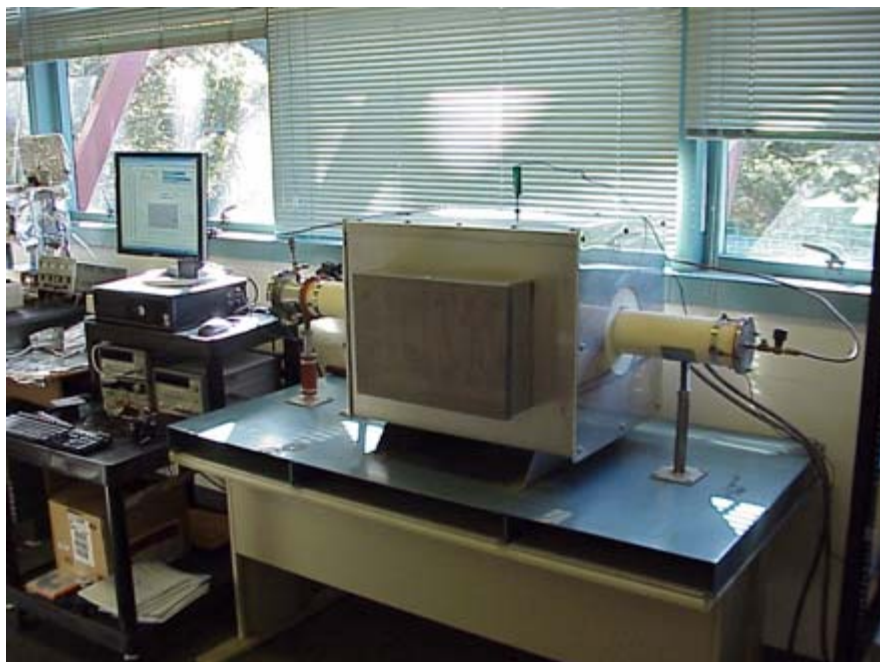
Figure 3. Picture of tube furnace and associated data logging computer.
